## Testing of DLR C/C-SiC for HIFiRE 8 Scramjet Combustor

7<sup>th</sup> European Workshop on Thermal Protection Systems and Hot Structures  
8-10 April 2013  
ESA/ESTEC, Noordwijk, The Netherlands

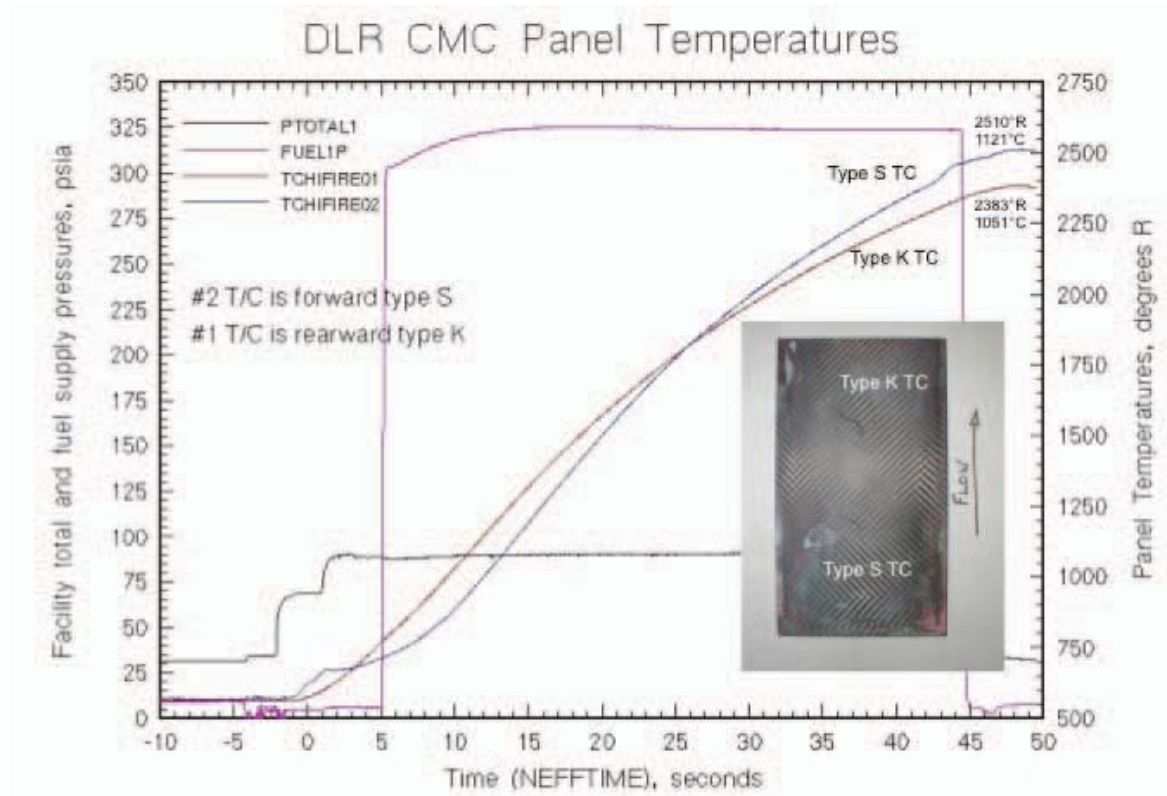
Figure 3: C/C-SiC panel test temperatures during Run 79

A plot of the data from the two embedded TC's is show in Figure 3 (for Run 79). The Type S TC reads a higher temperature, and was located upstream of the Type K TC. The facility total pressure (PTOTAL1) and fuel supply pressure (FUEL1P) are also shown on the figure. A photograph of the test panel post-test is also shown on the figure.

After the final run, the test panel was removed from the carbon steel fixture. Despite the high heating that the panel was subjected to during the last test and the melting of the steel sidewalls, the panel showed practically no damage, just a slight stain where the melted steel came into contact with the panel.

Very little recession was measured on the test panels. The largest recession was 0.051 mm. Several locations have zero recession. Table 2 shows the pre- and post-test thickness measurements, taken prior to the first run with panel C/C-SiC #1 and taken again after the last run with C/C-SiC #1. As indicated by the recession measurements and the post-test photographs of the panel, the panel survived the series of tests with negligible deterioration.

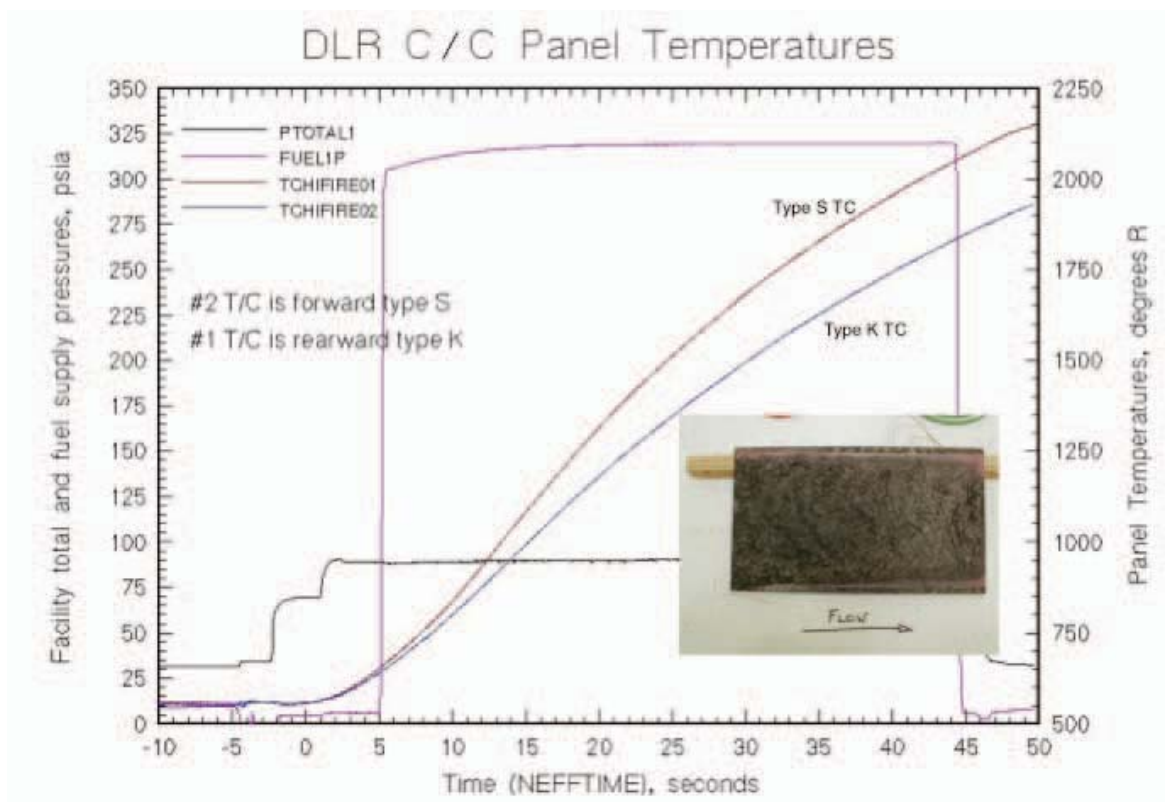
Figure 4: C/C panel test temperatures during Run 75

After the C/C-SiC panels were tested, a single C/C panel from DLR was also tested. A plot of the two embedded TC's is show in Figure 4. The Type S TC reads a higher temperature, and was located upstream of the Type K TC. The facility total and fuel supply pressures are also shown on the figure. A photograph of the test panel post-test is also shown on the figure.

As shown in Table 1, the panel was tested for 100 seconds at Mach 5 conditions, and 193 seconds at Mach 6 conditions. The measured recession data is shown in Table 3.

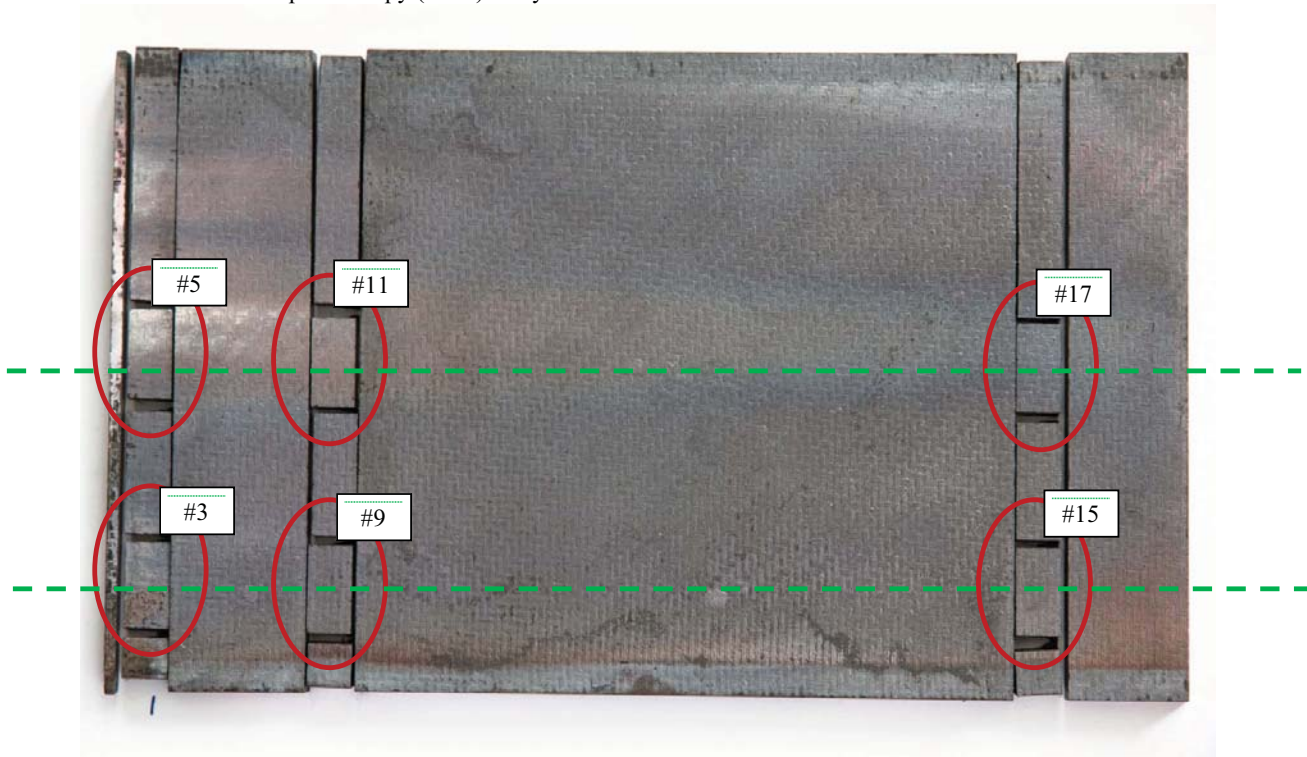
Figure 5: Panel 1 with cut pattern for the sample preparation

A number of samples were prepared on the centerline of the panel and on a line that was 20 mm from the side edge of the panel. The panel was cut into 19 pieces, and each piece was numbered accordingly. The samples were prepared for investigations in the SEM, i.e. they were embedded in a packing material and the surface to be investigated was ground and polished. For the investigations presented here, two samples from each panel were prepared. These were the cut-outs #5 and #17 from the centerline, as shown in Figure 5. Cut-out #5 was upstream on the panel closest to the combustor. Cut-out #17 was on the downstream end of the panel close to the nozzle exit.

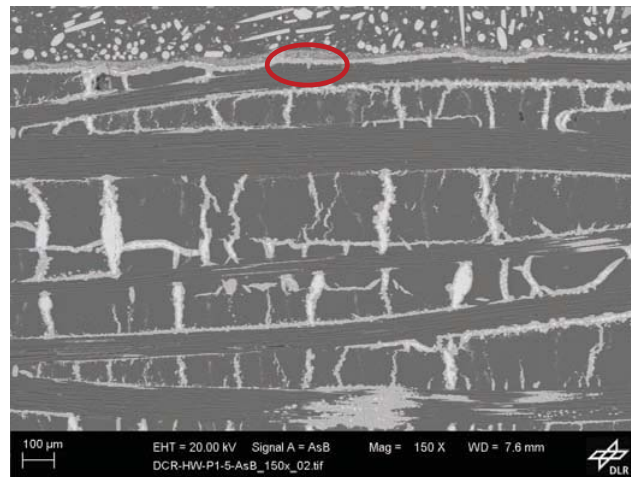
Figure 6 shows a scanning electron microscope (SEM) image with the typical C/C-SiC microstructure. Carbon fiber bundles are separated by crack volumes that are filled with SiC at the boundaries, and Si in the case when the width of the pore or crack is comparatively large. The surface of the sample is not flat due to the fact that it was not machined, so the topology of the fiber textile is seen. The area on the top part of the image where numerous bright spots appear is the packing material used for embedding the sample.

There is no evidence of significant oxidation which might have resulted in degraded fibers or matrix near the surface. What can be seen is a thin bright layer on the surface that was identified as silicon dioxide (or silica) using electron diffraction spectroscopy (EDX) analysis.

Figure 6: SEM image of sample #5 from panel 1. There is a thin layer on the surface that is identified as silica. The circle indicates the area that is shown in higher magnification in Figure 7.

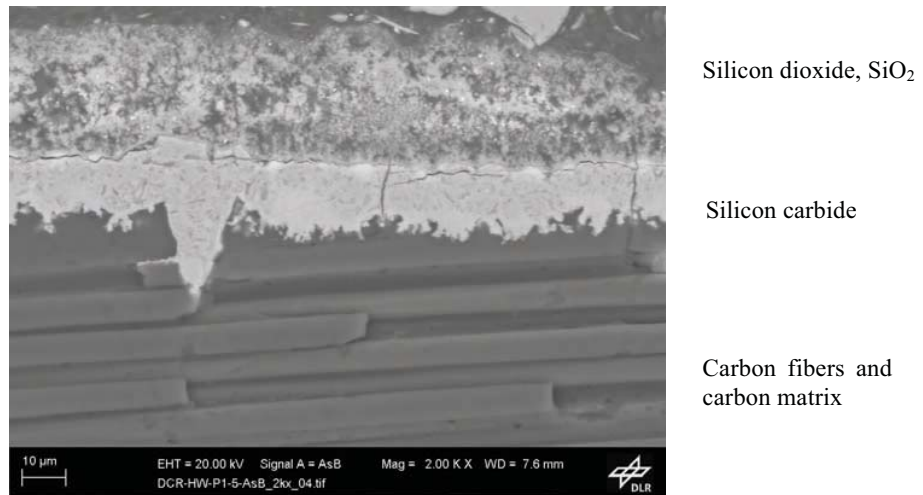
The close-up of the detail highlighted in Figure 6 is shown in Figure 7. The different material phases can be distinguished very well. There is a fiber bundle with silicon carbide on the surface. On the surface, above the silicon carbide is a thin layer of silica of around 20  $\mu\text{m}$  thickness. The  $\text{SiO}_2$  layer on the surface does not have a constant thickness in every location over the sample. There are some spots where no  $\text{SiO}_2$  layer can be found and there are locations with a thinner layer compared to Figure 7, but in general, there is a  $\text{SiO}_2$  layer over most of the sample.

Figure 7: SEM image of the  $\text{SiO}_2$  scale on top surface of the sample

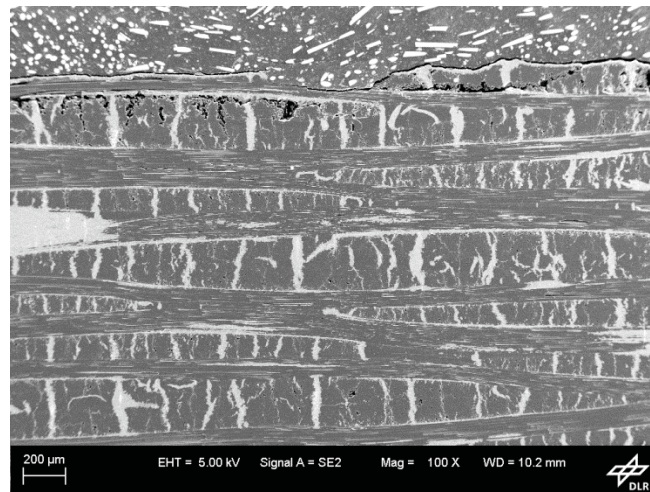
Figure 8: SEM overview image of sample #17 from panel 1, exposed surface is on the top

Figure 8 shows the surface of sample #17 from the end of the panel. There are a few cracks and pores in the two topmost layers. These could be the result of oxidation of the carbon since close-up images show signs of oxidation

in the pores at fiber ends and on the matrix; however, the amount of pores was significantly smaller in other samples, so in part they can also be the result of sample preparation as there is a tendency of sample material to break out at the edges due to the relative softness of the surrounding packaging. Figure 9 shows a close-up SEM image showing some indication of matrix oxidation in the pore. Note the clean-cut ends of most of the fibers as the result of the preparation. The circle indicates the region detailed in Figure 10.

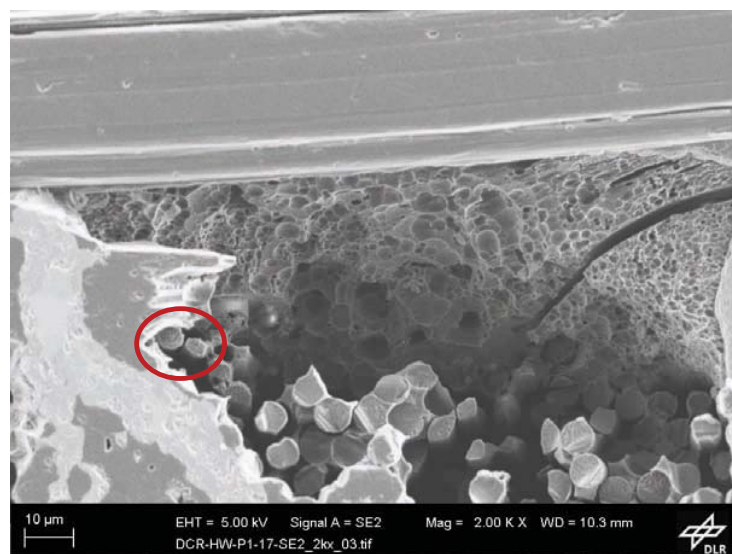
Figure 9: Close-up SEM image showing some indication of matrix oxidation in the pore.

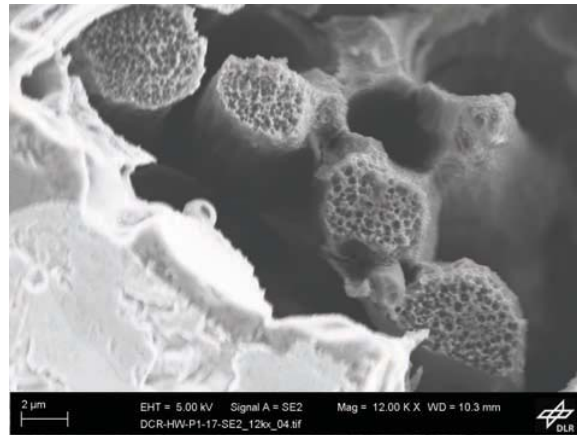
Figure 10: SEM image of fiber ends that have a rough cross-section which is interpreted as the effect of oxidation.

The conclusion is that there was some oxidation on the surface of the panel, but limited to only the topmost one or two layers, with no significant degradation of the panel.
